## IR camera images show heat reflection, cooling effect of 24/7 FCSC

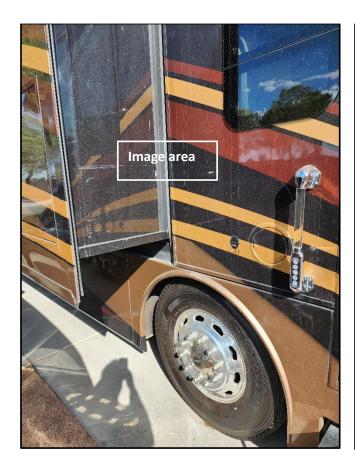
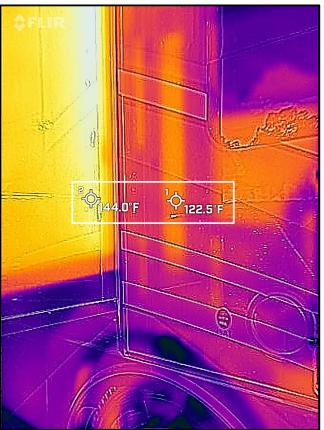
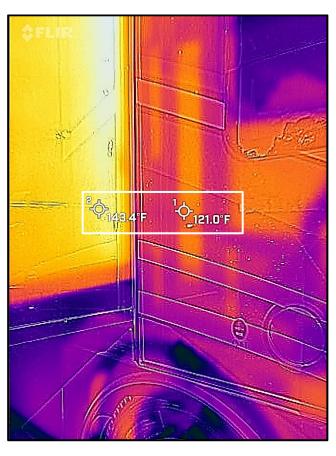
2016 Thor Tuscany 45' motor home in Las Vegas, Nevada May 22, 2023; Temperature 91 F at 4:36pm. 2 images 3 minutes apart. Slide out was not extended when Motor Home was cleaned then sealed. Paint on sidewall of slide out same black as black on body. Two images average temperature: un-sealed slide out avg 143.7 deg. F. and sealed body avg 121.75 deg. F. Surfaces sealed with 24/7 FCSC is 22.45 deg. cooler than where un-sealed.
